National Register of Historic Places
Registration Form

historic name Linnwood
other names HO-570; Cobb, Samuel F., House

street & number 2327 Daniels Road ☐ not for publication
city or town Ellicott City ☒ vicinity
state Maryland code MD county Howard code 027 zip code 21043-1909

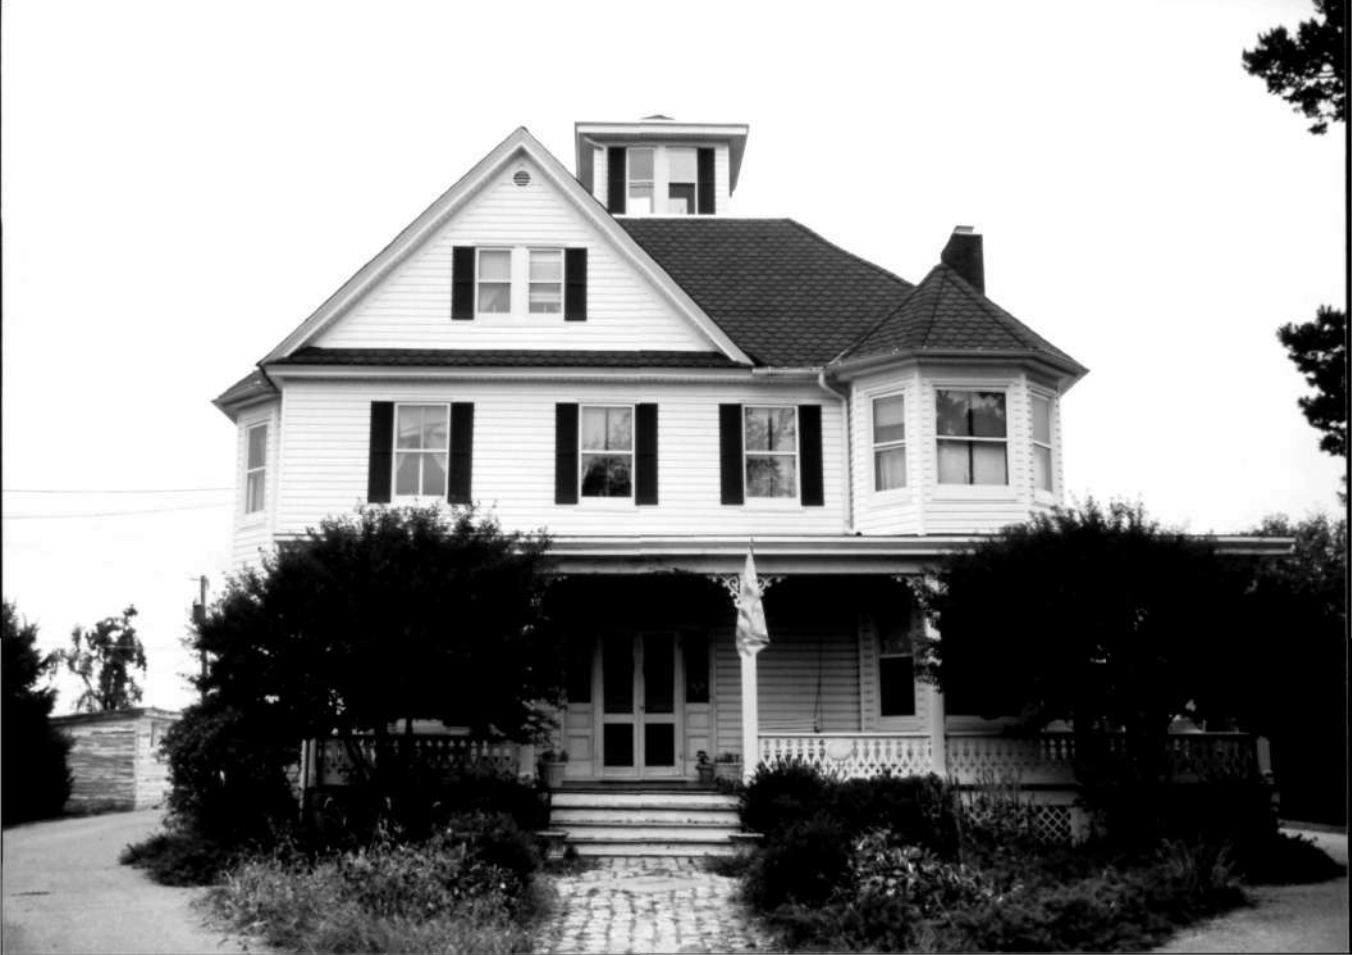
1/13

House SW elev.

The southwest elevation, on the first story, has a two-over-two sash in the west bay. There is a pair of three-panel doors, with bolection mouldings and the small panels in the center, in the west-center bay. There are sidelights with two stained glass lights over two bolection-moulded panels, and a transom with four stained glass lights. The jambs are chamfered, with run-on stops. There is nothing in the south-center bay, and the south bay has a three-sided bay window with a two-over-two sash flanked by a one-over-one on each side. There is a one-story porch that wraps around the southeast. It has six large square posts with rounded-off corners and a torus above an ogee creating a rudimentary capital. There are jig-sawn brackets, a plain frieze, and a box cornice with an ogee. The balusters are also jig-sawn. The second story has three two-over-two sash and a bay window that matches the first story. There is a gabled wall dormer with paired one-over-one sash that spans 2 ½ bays, and a turret roof on the south-bay window.

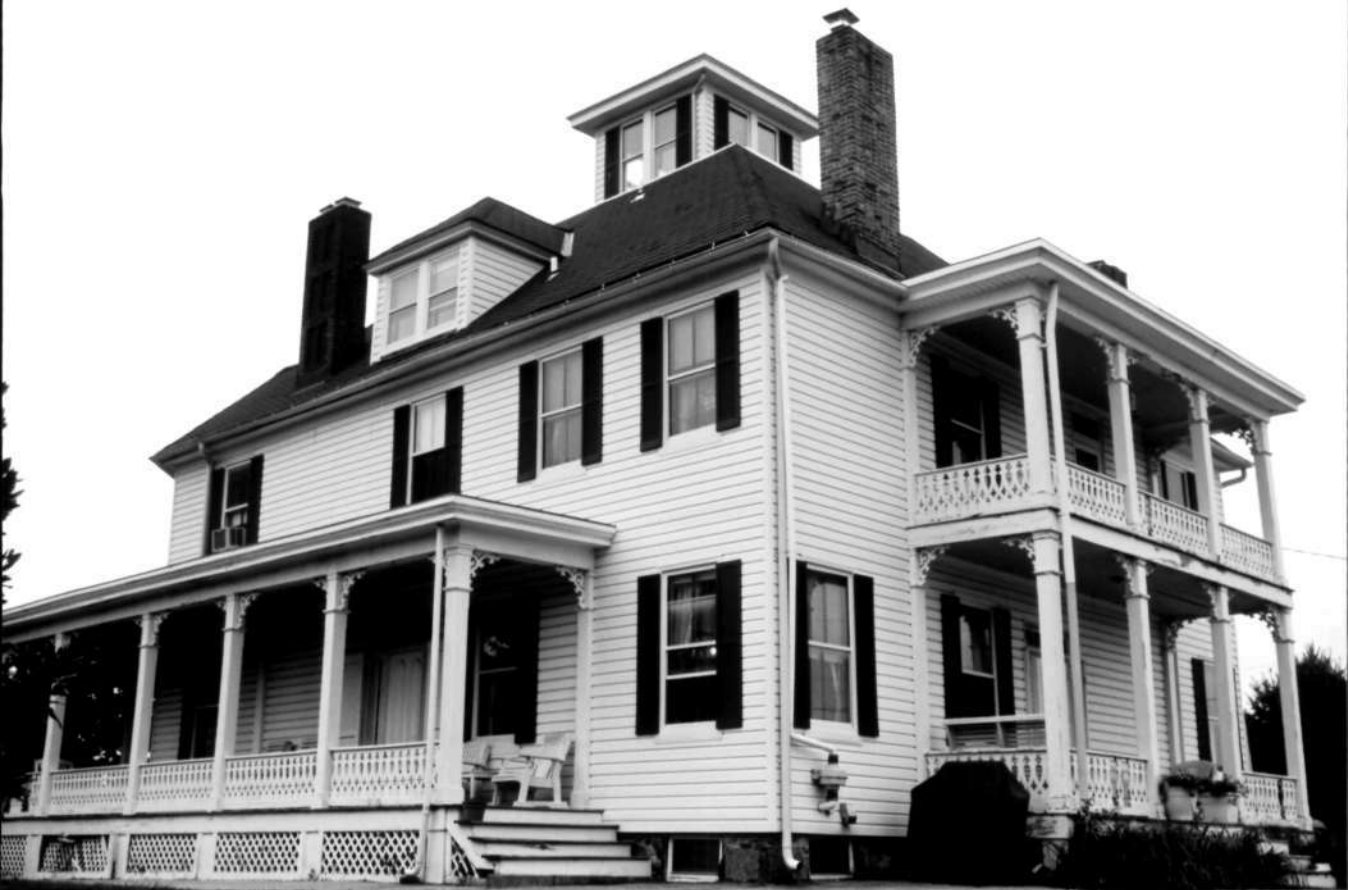
2/13

House - SE & NE e LeWS

On the southeast elevation, the first story has a two-over-two sash in the south bay. There is a four-panel door in the south-center bay that has round-arched top panels and bolection mouldings, and sidelights with three lights over one panel that has sunken fields and quirked Greek-ovolo-and-bead panel moulds. The jambs are chamfered, with lamb's-tongue stops, and there is a transom with three lights of frosted glass. The east-center and east bays each have a two-over-two sash. The porch stops short of the east bay. The second story has four two-over-two sash. There is a hip-roof dormer with a pair of one-over-one sash over the south-center bay, and a paneled interior brick chimney to the south of it.

The northeast elevation has a two-over-two sash in the east and east-center bays of the first story. The north-center bay has a four-panel door with square panels that have bolection mouldings. There are sidelights with two lights over one bolection-moulded panel, and a three-light transom. The north bay has a two-over-two sash. There is a two-story porch in the center, with four posts and details that match the front porch. The second story has no opening in the east bay, and a two-over-two sash in the east-center bay. There is a four-panel door in the north-center bay, set to the north of the door below, with a two-light transom that has vestiges of painted decoration in a diamond pattern. The north bay has a two-over-two sash. There are two paneled-brick interior chimneys set even with each end of the porch.

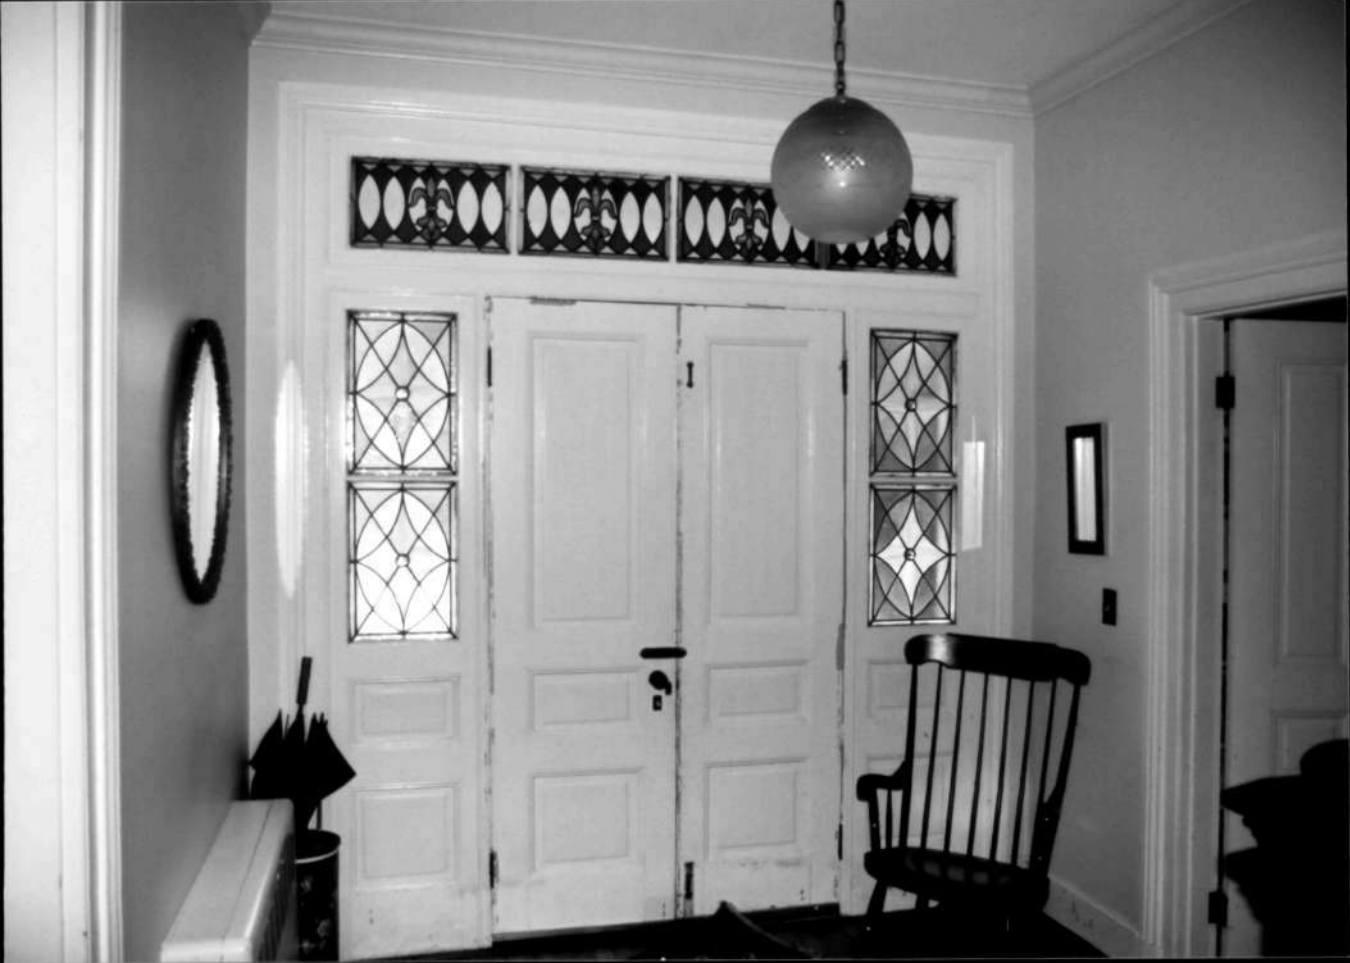
3/3

House - SW door, interior

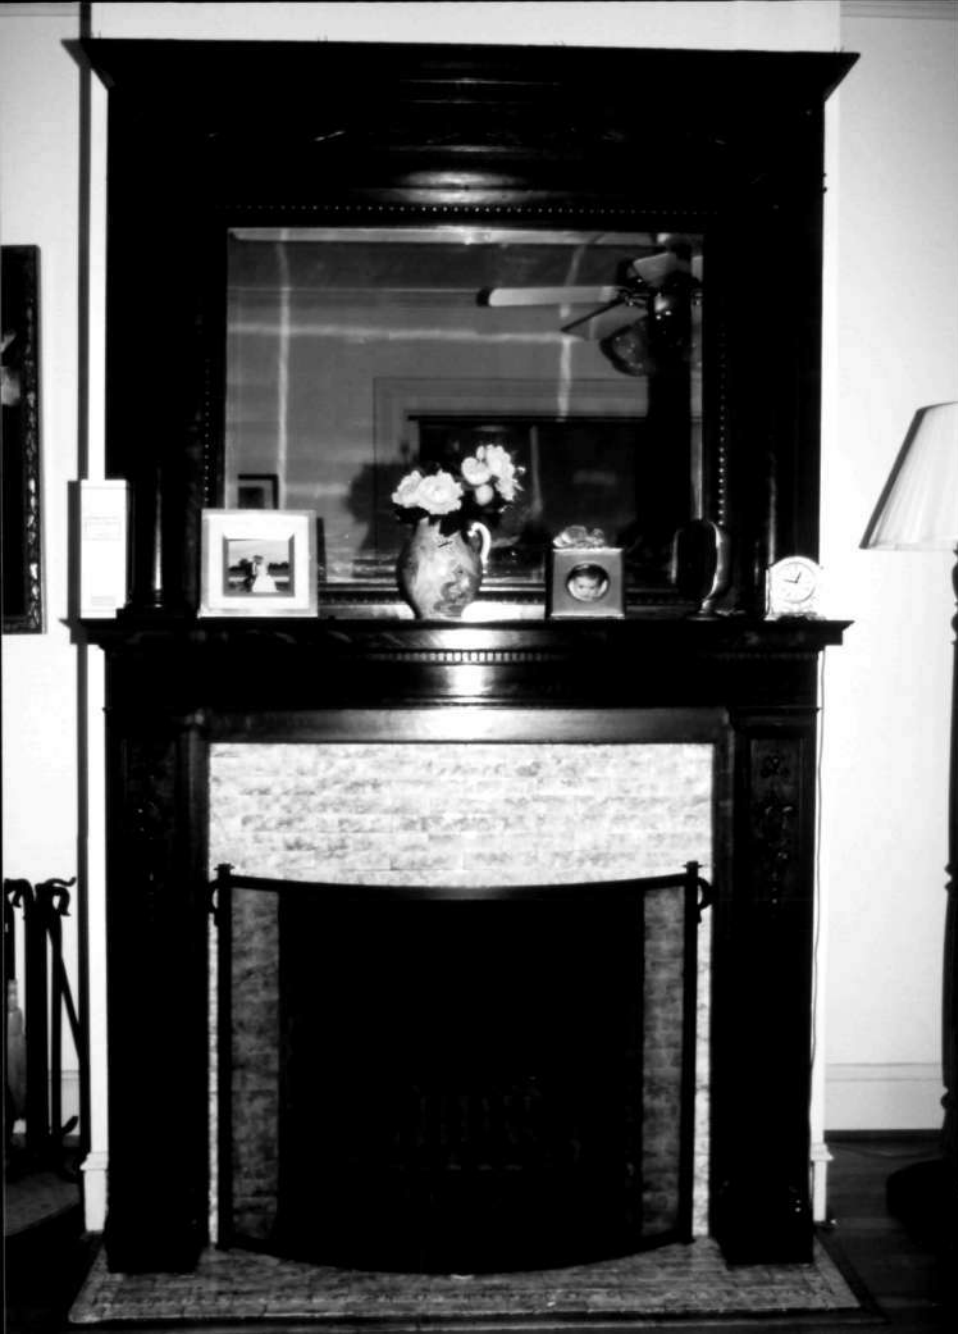
6/13

House - S. Rm. mantel

The south room has typical flooring, baseboard, architrave, and cornice. The sash are hung on chains, have parting beads and a check rail, and are mortised and tenoned, but are not pinned. There is a fireplace on the southeast that has a brick firebox that has been rebuilt and the opening lowered to meet code. There is a hearth and surround of mottled green tile with a moulded band on the hearth, and a clean-out in the bottom of the firebox. The northeast side of the fireplace has a cast-bronze foliate heating grate. There is an oak mantel with paneled pilasters that have bell flowers below a cartouche hanging from ribbon. The pilasters support a bowed entablature with bead and reel on the architrave and a dentil cornice. The oak overmantel has Ionic columns that support a full entablature with a bead and

reel on the architrave, a frieze with alternating anthemion and acanthus, and a dentil cornice. There is a beveled glass mirror in an egg and dart-moulded frame. The bay window on the southwest has wood corner bead.

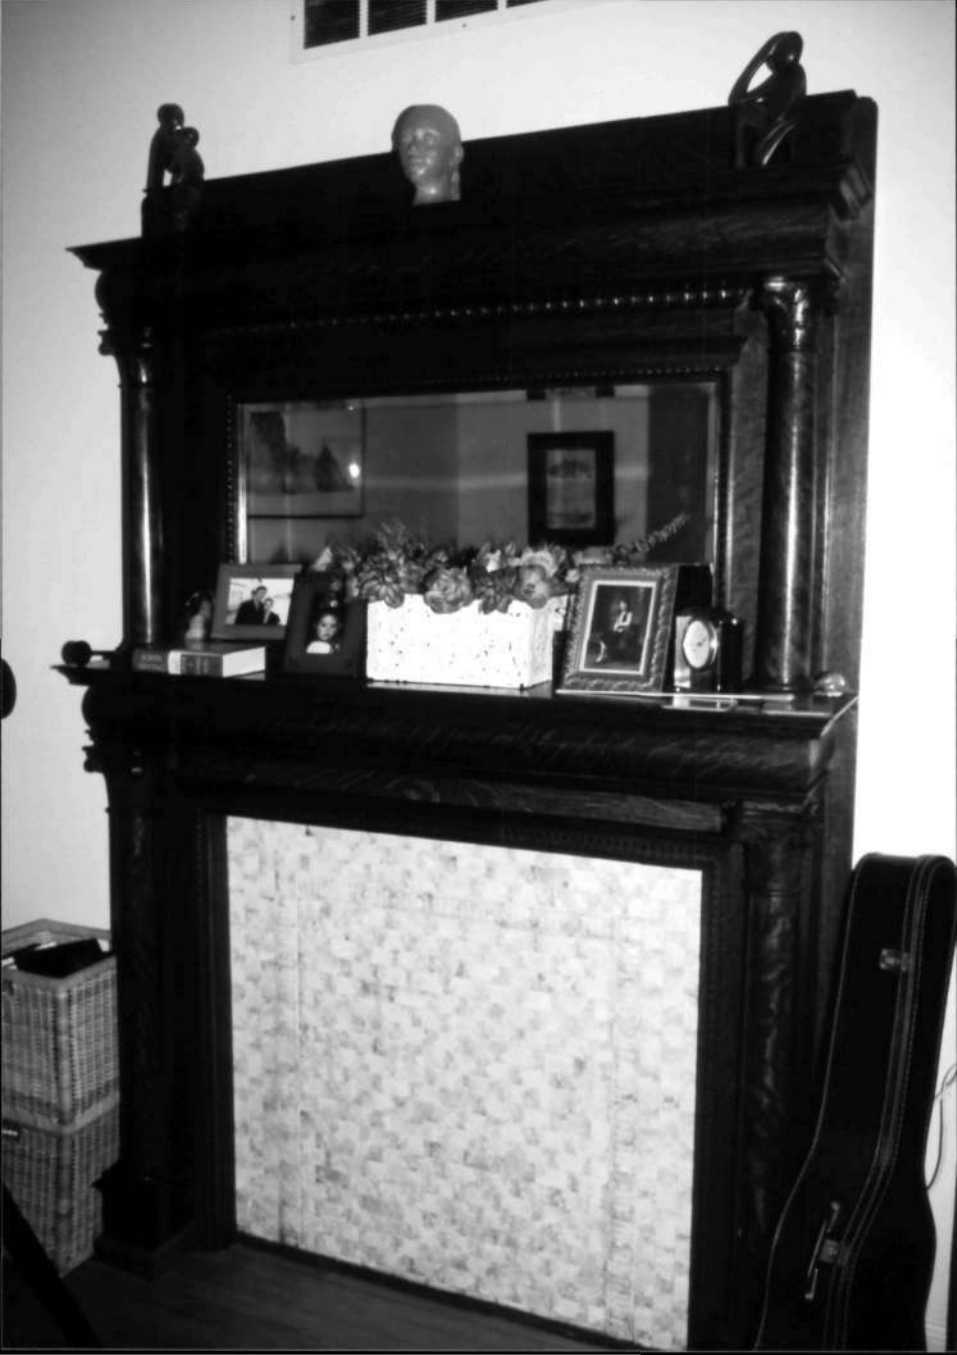
7/13

House - W. Room added

The west room has typical flooring, baseboard, architrave, and cornice. The bay window on the northwest has wood corner beads. There is an oak mantel on the southeast that never had a fireplace. The "opening" is covered with mottled green and pink glazed tile that has a moulded band of ovals. There is an egg-and-dart moulding in oak around the "opening," with a dentil cornice above and an egg-and-dart bed mould. There are composite columns that support a pulvinated frieze and cornice. The oak overmantel also has composite columns and a beveled glass mirror with the same surround, bed mould, and pulvinated frieze and cornice as below.

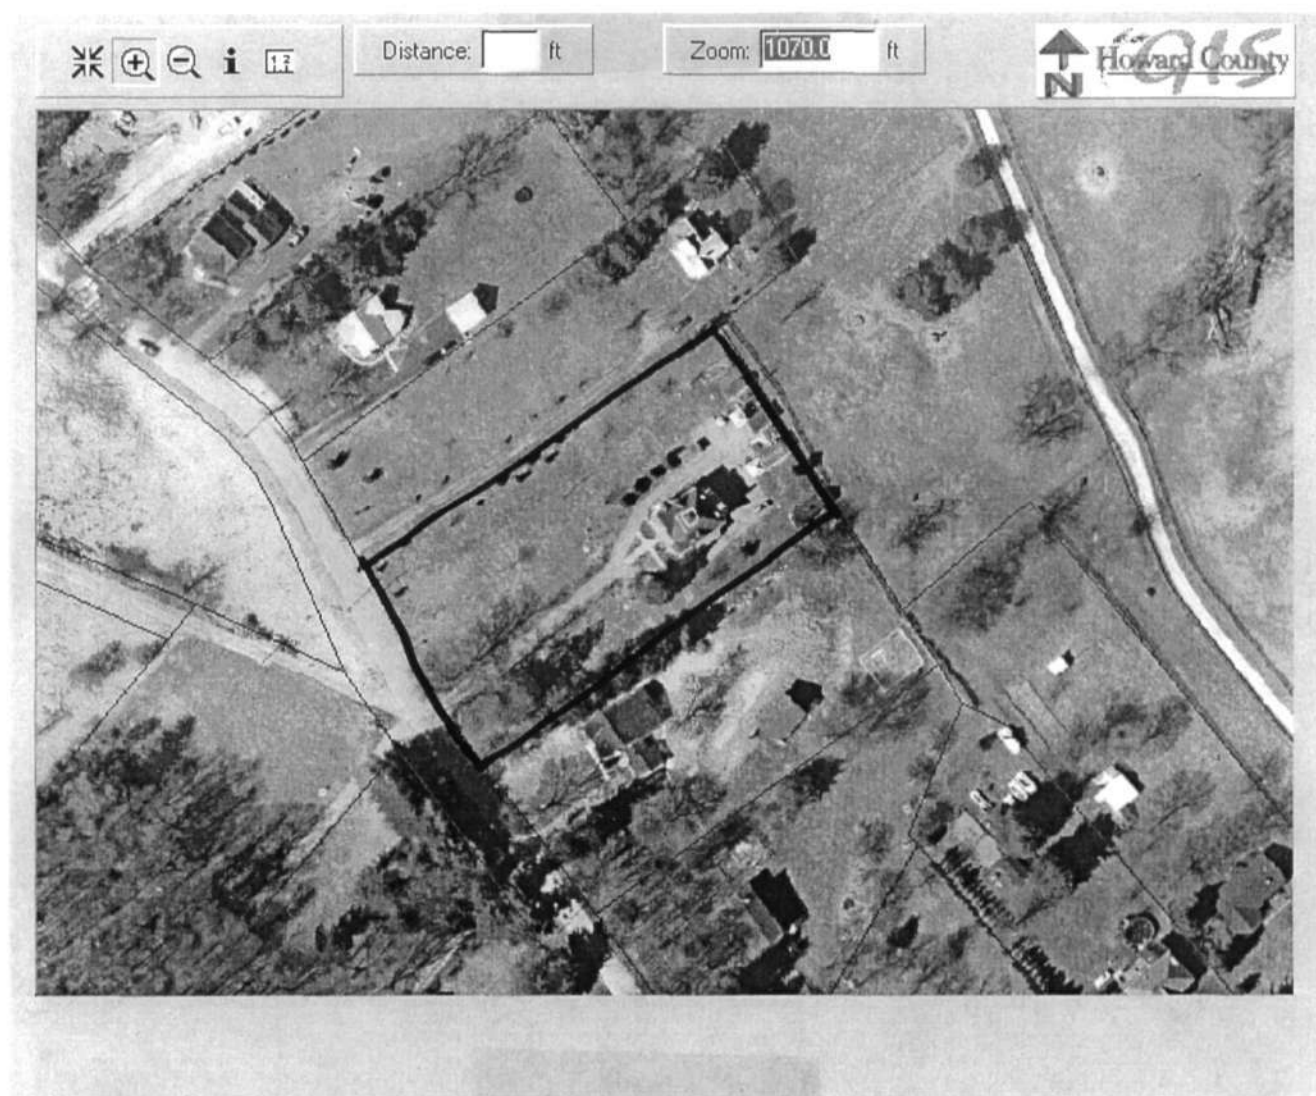
Linnwood (HO-570)
2327 Daniels Road, Ellicott City
Howard County
Site plan/Aerial photo

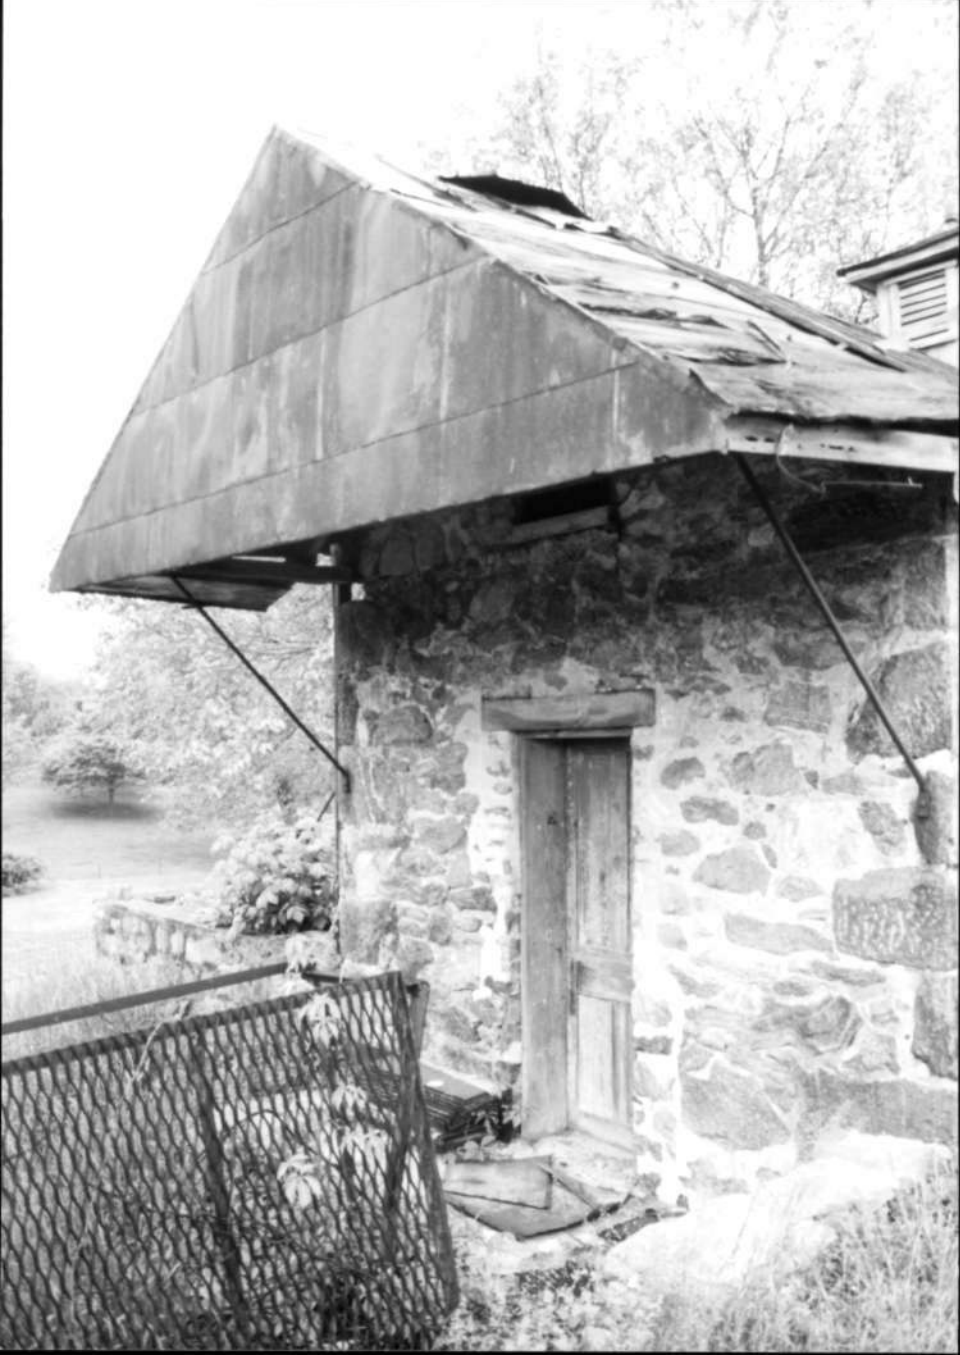
12 of 19

View South. Shows green house

installed in mid-September, when Cobb could write that the building was all done "except a coat or two of paint, which we will apply next month when the flies and nats [sic] are gone." The diary never explains where the greenhouse was, but the remains of it exist. The stone building that was apparently originally a springhouse had the southeast wall of both rooms opened up and a foundation survives to the southeast, with the iron rods and wheel used to open the ventilators still hanging from the side of the stone building. Local lore calls this the greenhouse, and the physical evidence corroborates it.¹⁹

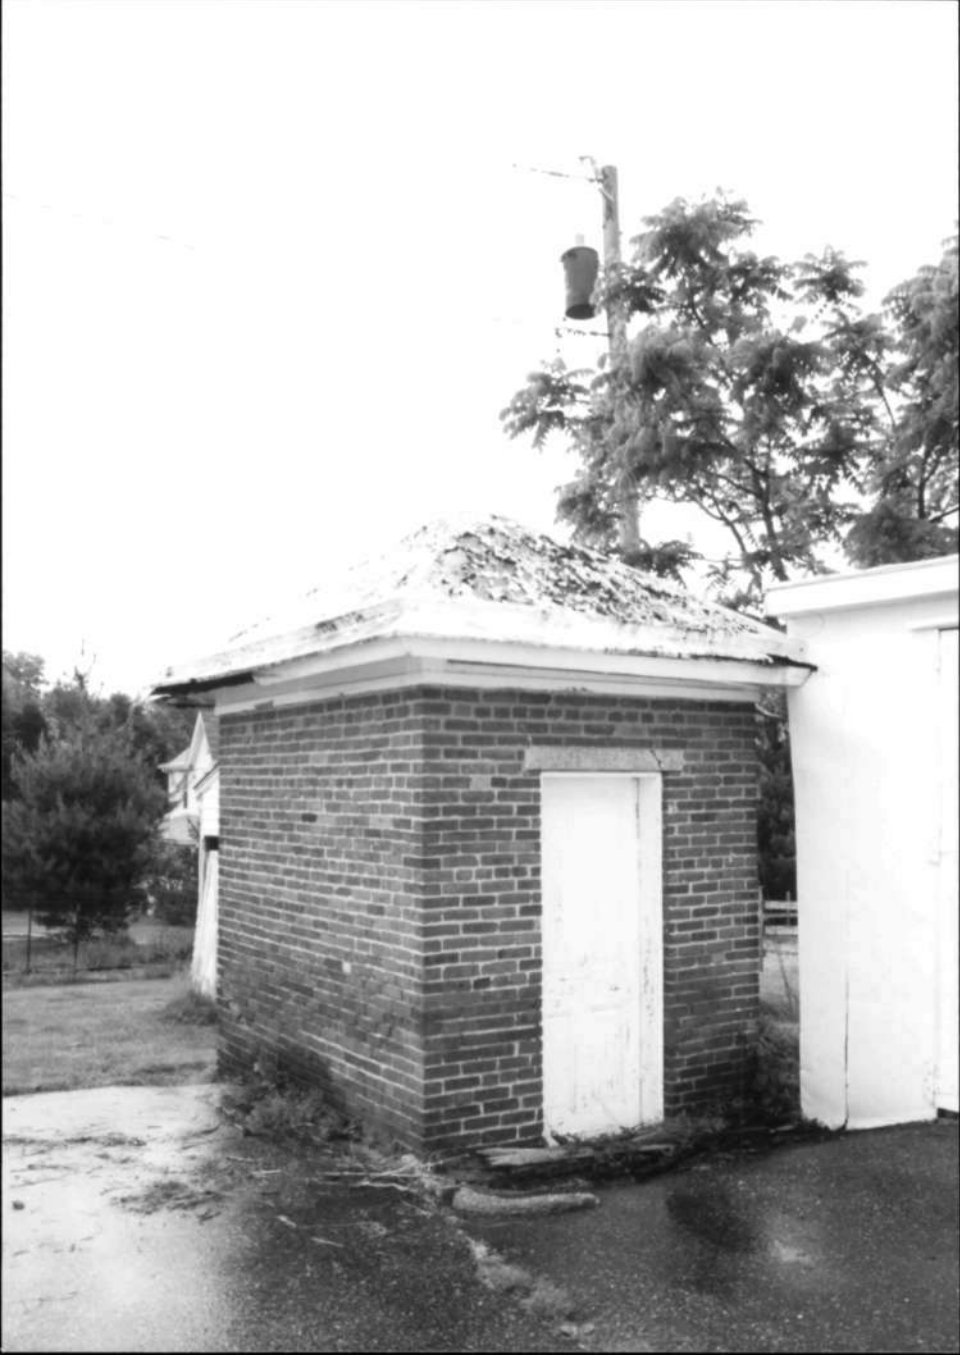
150619

View east, shows meat house.

A brick, hipped roof meat house is located northeast of the house. The one-story building with a square footprint has a stone foundation, brick common bond walls, a door opening with a granite lintel, and a metal roof. The building is suffering from deferred maintenance. The brickwork shows the evidence of rising damp and paint on the metal roof and wood door is peeling. The primary façade of the meat house faces west and encloses a door opening, which holds a four panel wood door. The other facades do not have any openings.
